Invasive alien species in aquatic environments
Practical information and management insights

Volume 2

Management insights

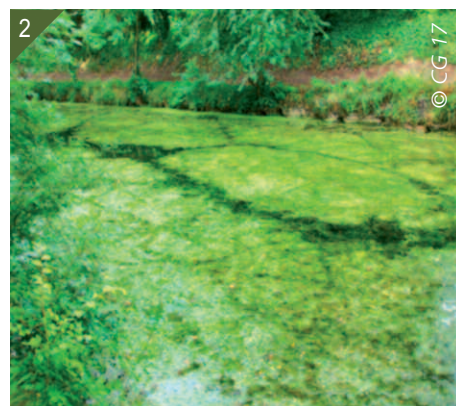
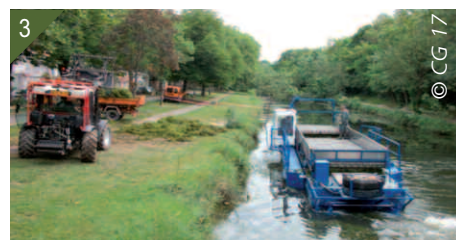
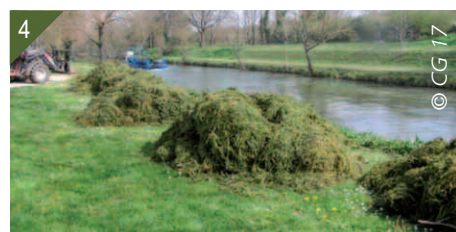
2. Zone colonised by *Egeria densa* and algae.
3. Harvester boat and transport of plants.
4. Piles of cut plants deposited on the banks.

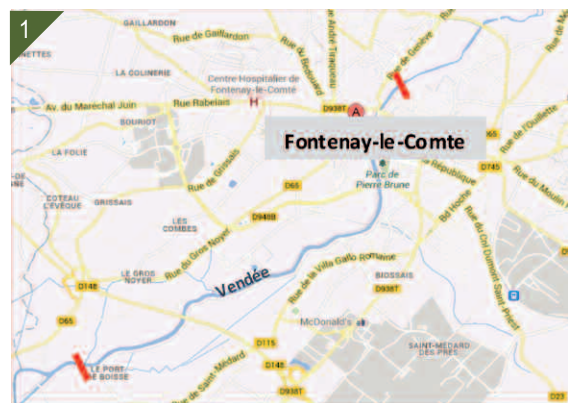
1. Section of the Vendée River where the work took place in 2012 (the limits are shown in red).

- The intervention site is a reach of the Vendée River located in the town of Fontenay-le-Comte (85). The Vendée River is a tributary to the Sèvre-Niortaise River and flows through the Marais Poitevin marshes.
- In 2012, the work was carried out on a reach 3.5 kilometres long. A weir in the town marked the upstream limit and the Boisse dam the downstream limit of the site.
- Upstream of the intervention site is the Mervent reservoir that is used as a supply of drinking water and as a means to attenuate low-flow levels and manage flooding

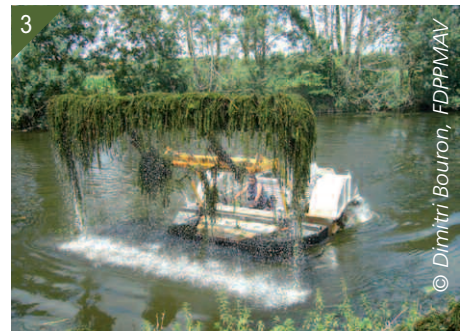
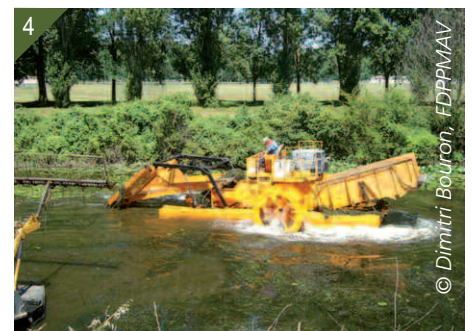
3. Pusher-harvester boat.

4. Harvester boat.

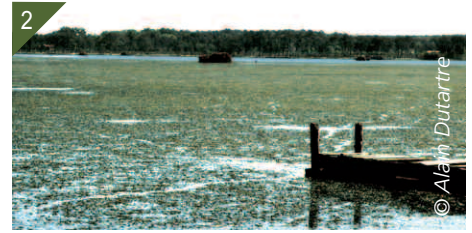
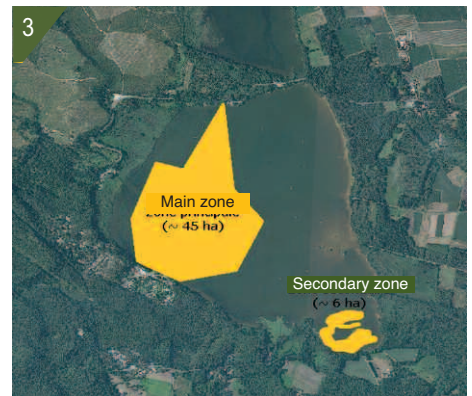
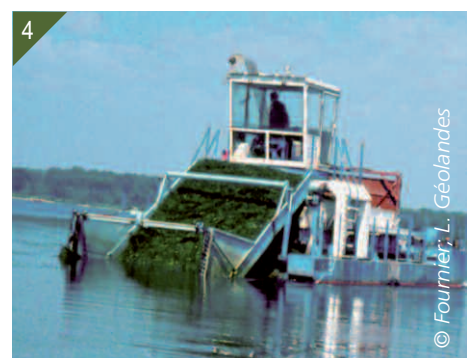
2. Blanc Pond colonised by *Lagarosiphon major*.
3. Potential harvesting zones.
4. Harvester boat.

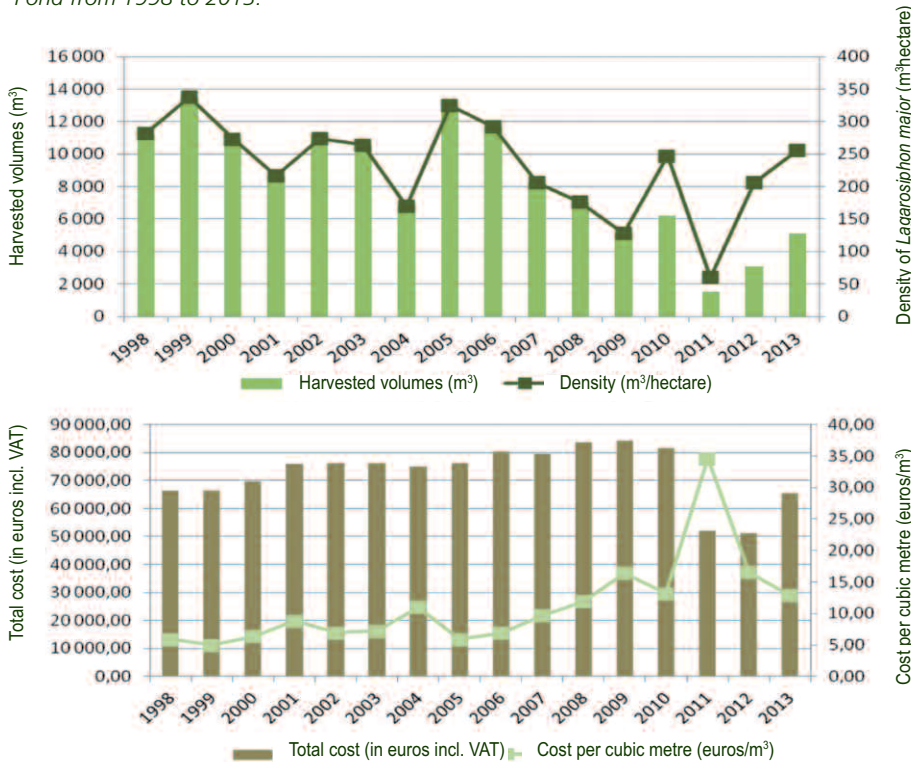
Total cost and cost per cubic metre of work to manage *Lagarosiphon major* in the Blanc Pond from 1998 to 2013.

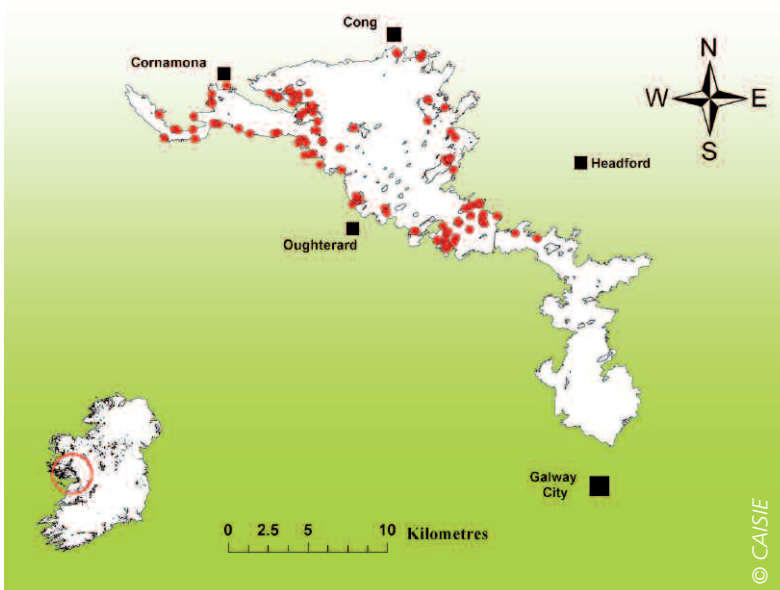
Distribution of *L. major* in Lough Corrib in 2007.

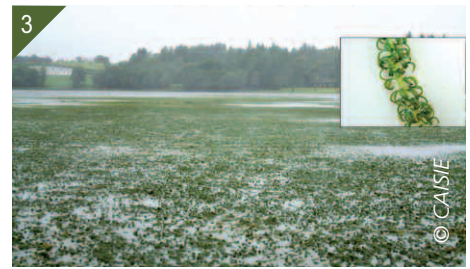
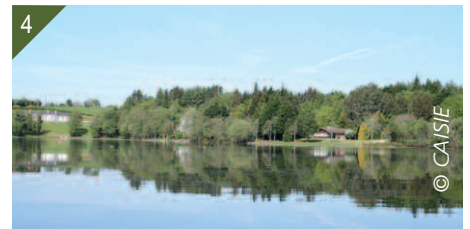
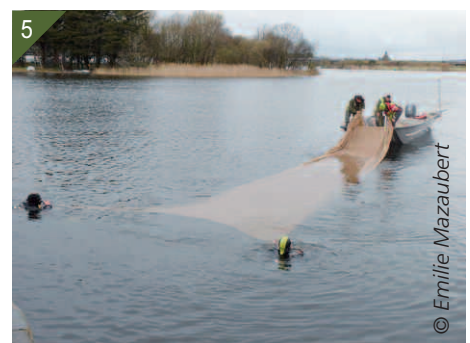
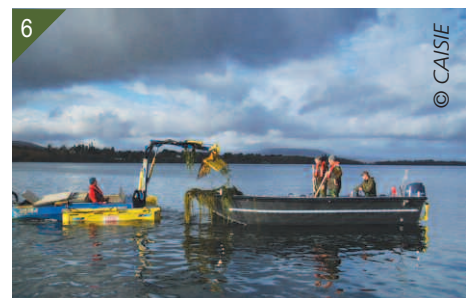
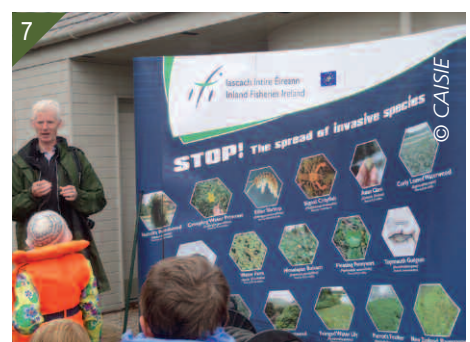
3. 4. Lough Corrib, before (1) and after (2) the management work on curly waterweed.
5. Installing a biodegradable geotextile in Lough Corrib.
6. Cutting and harvesting of plants.
7. Efforts to raise the awareness of school children.

- blocking the light by laying a sheet of biodegradable burlap along the bottom of the lake from the beginning of the summer to the beginning of the fall. The burlap was positioned using boats. The fabric was supplied in rolls 5 metres wide and 900 metres long, with a density of 200 grammes per square metre;
- mechanical cutting using V-shaped bars capable of reaching the roots, during the coldest months (mid-fall to the beginning of April). Nets were installed to avoid dispersal of fragments of curly waterweed and to facilitate mechanical recovery of the plants;
- manual uprooting by divers in areas where plant densities were very low.

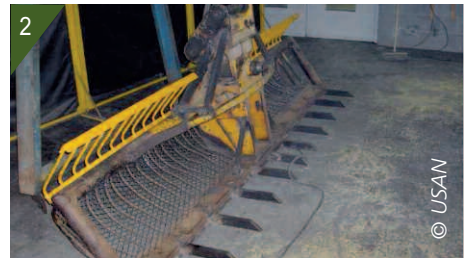
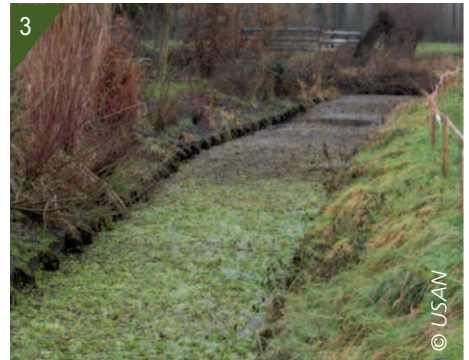
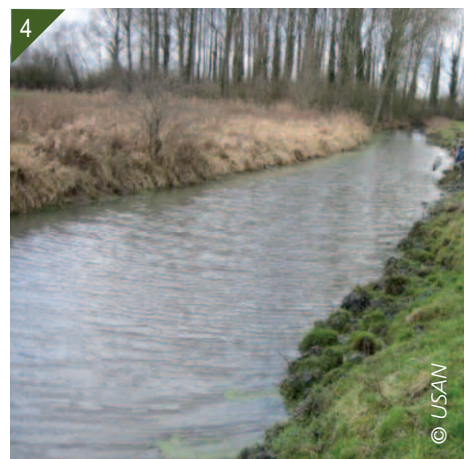
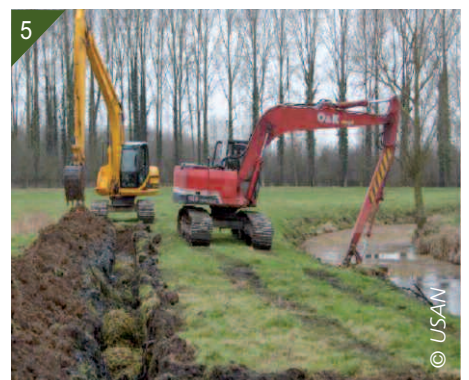
2. Harvester bucket with screen.
3. River section prior to the work.
4. River section after the work.
5. Mechanical uprooting.

- The project was a success thanks to the constant monitoring of the river section following the work in 2006. The section was inspected every 2 months up to 2009 and then every 4 to 6 months until 2011.
- No new colonisation by water pennywort had been noted as of the last inspection in 2011.
- Burial of the plants produced no problems. No regrowth was noted in the ditches.
- The work was done by in-house personnel, the costs were not calculated.

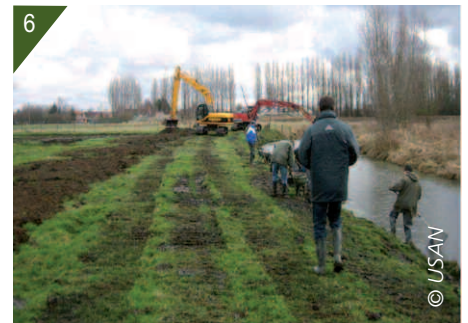
6. Manual collection of cuttings following the mechanised intervention.

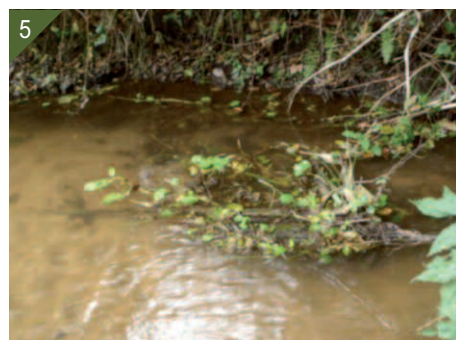
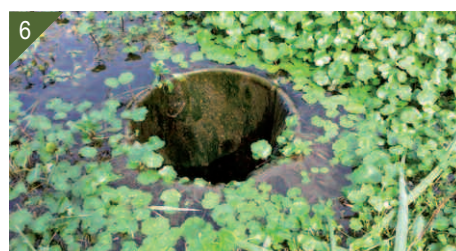
5. Cutting of water pennywort.
6. Overflow outlet of the Lagrollet Pond invaded by water pennywort prior to the installation of screens.

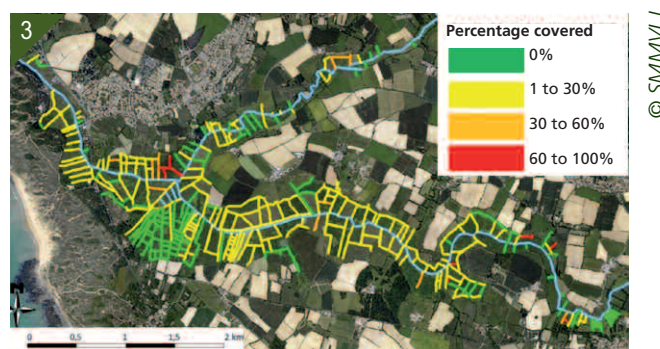
2. Percentage covered in 2007.

■ *Ludwigia* spp. and PFW were first observed in the Jaunay and Gué-Gorand marshes in 1994. They have now colonised the entire marsh (570 hectares), i.e. a total of 64 kilometres of rivers and ditches. The percentage of covered surface area ranges from 1 to 90%.

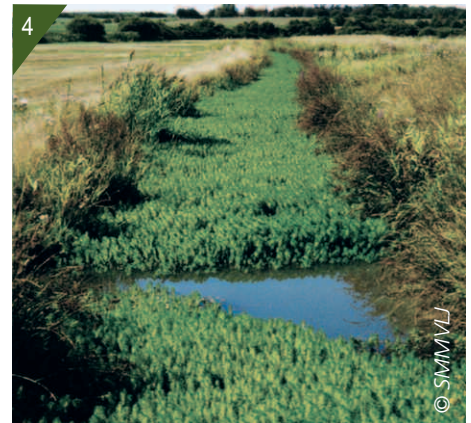
4. Canal colonised by PFW.

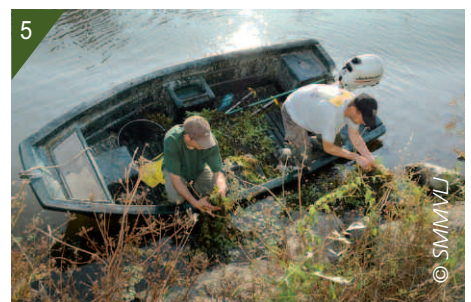
5. Manual uprooting using a boat.

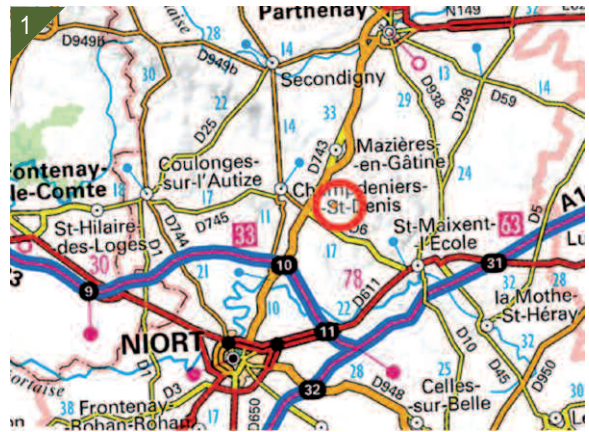
1. Intervention site

- Approximately 250 square metres (10 x 25 m) of the pond surface were covered by NZZ. The water depth varied from 20 to 60 centimetres with between 20 and 40 cm of sediment.
- The pond belonged to a farmer and was located along a road.
- The pond received water from a fountain, but was not connected to the aboveground hydrographic network. The nearest stream was the Raganier Stream, located 500 metres away.

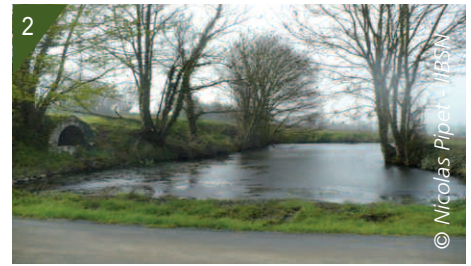
2. Intervention site.

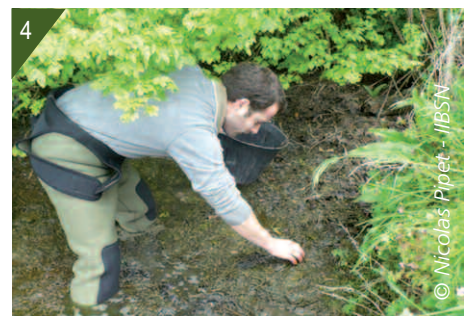
3. Beds of NZP.

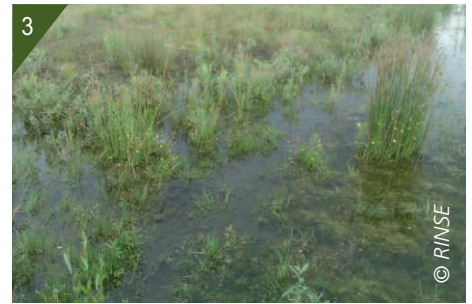
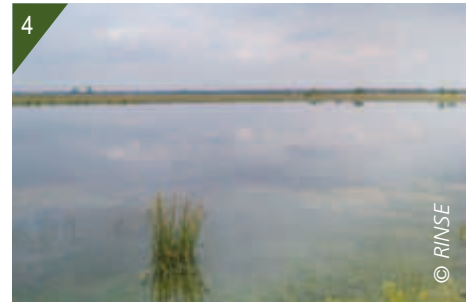
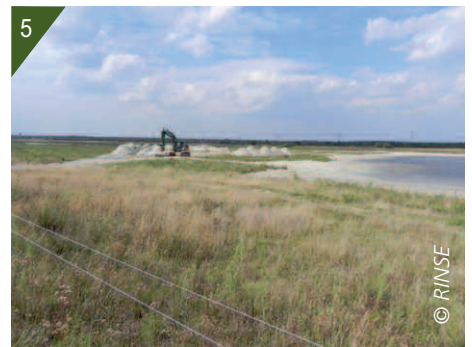
3. 4. The colonised pond, prior to the work.
5. Dredging work.
6. Site following the work.

- The results in the emergent areas of the site were very encouraging. No regrowth has been noted to date following the removal of 20 centimetres of topsoil and the installation of the tarps.
- On the other hand, the results in the pond were mixed:
 - there was no significant reduction in NZP after the initial use of the dye, even though the recommended dosage (100 µg.l-1) was exceeded each time;
 - the reduction in the luminosity achieved by the dye was insufficient, except in the deepest part of the pond and for very short periods.

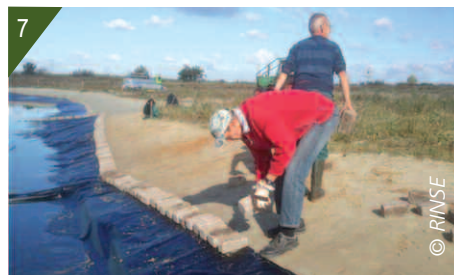
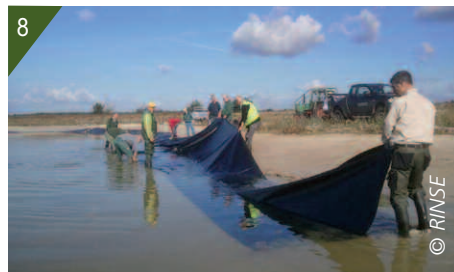
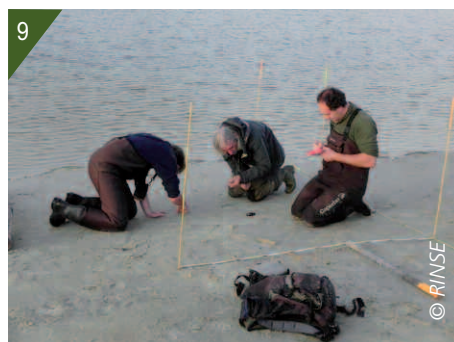
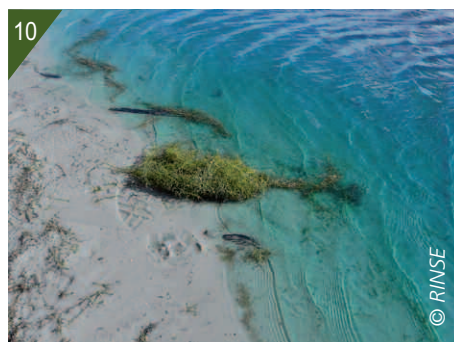
7. 8. Laying of the plastic tarps.
 9. Creation of the monitoring sites.
 10. NZP fragments following the use of Dyofix.
 11. Spreading Dyofix in the water.

- The use of Dyofix (an anti-algal, triarylmethane dye) was planned. This dye limits luminosity in the aquatic environment, thus hindering photosynthesis and plant growth.
- In October 2012, the application for a waiver to use Dyofix was submitted.
- Voluntary personnel monitored the ponds on the entire study site. NZP was detected on two new sites.
- New management recommendations were implemented:
 - the exposed banks of the pond were covered with opaque sheets of plastic (tarps);
 - monitoring sites were established;
 - newly colonised sites were reported and eliminated or isolated;
 - monitoring was set up for NZP fragments that drift off and colonise neighbouring sites.

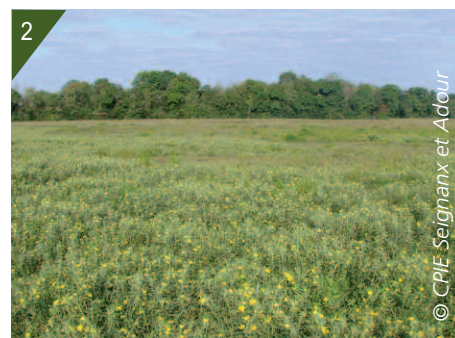
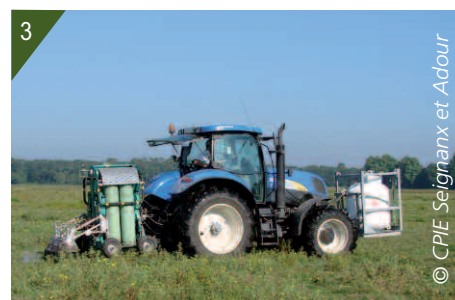
2. Meadow invaded by *Ludwigia grandiflora*.
3. Tractor equipped with a burner.

- Thermal weed control using a burner.
- Mowing (only on the Barthe de Castetbieilh wet meadow):
 - using a brushcutter on 6 E-type plots;
 - during the period from June to August;
 - the cut water primrose (three 100-litre bags) was stored and dried in a glass-house outside the wetlands (on the CPIE site 34 kilometres from the study site).
- Mowing and thermal weed control (only on the Barthe de Castetbieilh wet meadow):
 - the first test was conducted in 2011;
 - the protocol was the same as for simple mowing, but with thermal weed control.

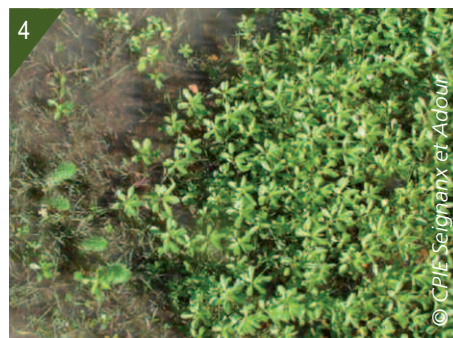
4. Plot prior to thermal weed control (June 2012).

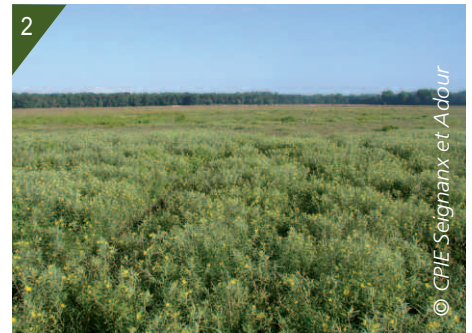
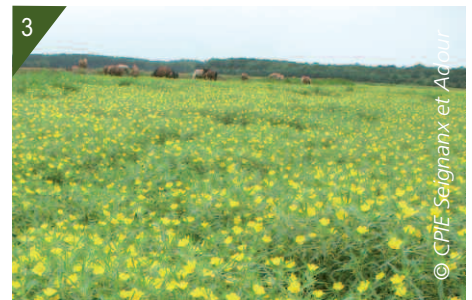
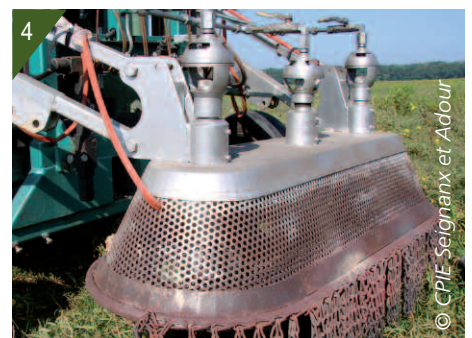
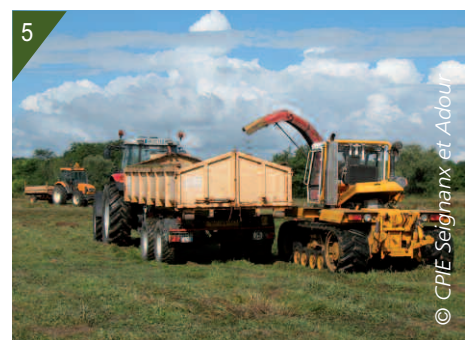
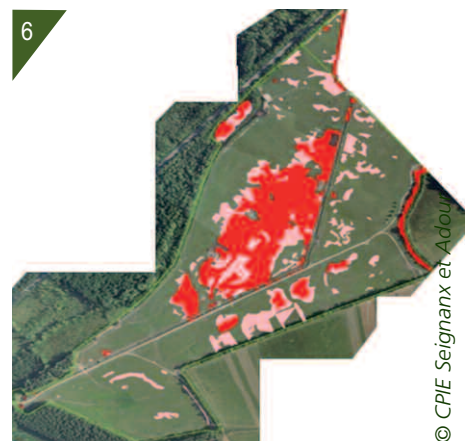
2.3. Meadow invaded by *Ludwigia grandiflora*.
 4. Burner for thermal weed control.
 5. Ensiling (chopping) the water primrose.
 6. Map showing water primrose in a municipal meadow (dark red = high density, light red = low density).

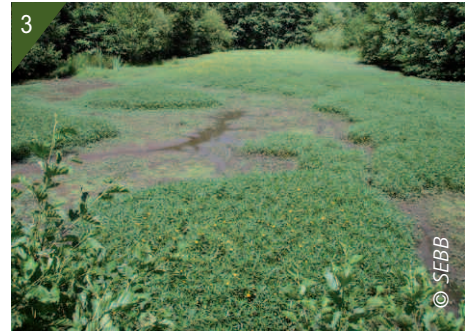
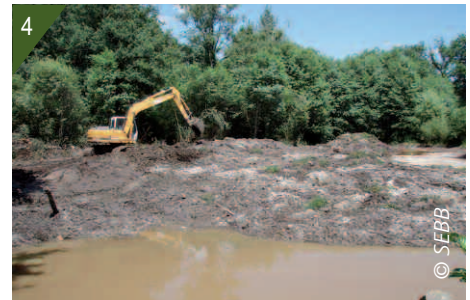
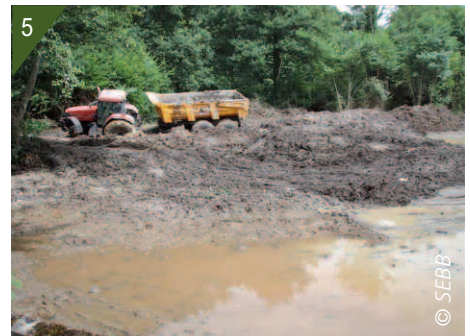
3. The drained pond.

4. Work to uproot the plants and strip the top layer of sediment.

- Manual uprooting was included in the project for several reasons:
 - uprooting was undertaken around the emergent native riparian vegetation to help it develop and compete with the water primrose;
 - following the mechanical uprooting, it was required to remove the new shoots that generally appear after a few days. This occurs because the excavator bucket tends to leave many rhizomes in the soil during uprooting. It was therefore essential to include manual uprooting in order to reduce recolonisation by the plants. This work was made easier due to the very small volumes involved.

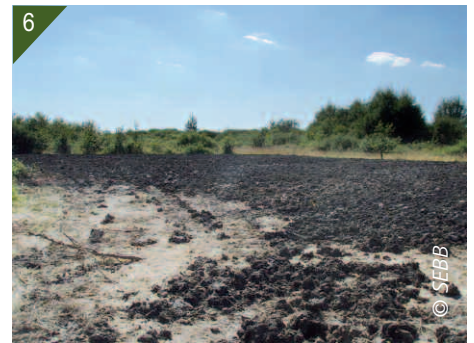
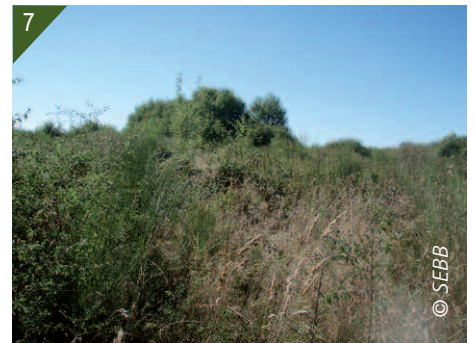
6. 7. The meadow prior to the work (2008) and in 2013.

- The owner was trained to identify water primrose so that she could carry out manual uprooting herself.
- * Monitoring of the meadow where the waste was spread:
 - the drying time was longer than planned given the thickness of the spread material;
 - in 2009, the very hot summer resulted in the disappearance of the stands of reeds in the meadow and the appearance of grasses;
 - in 2010, wetland plant species such as reeds and hemp-agrimony (*Eupatorium cannabinum*) reappeared, signalling that the soil on the site still contained a high degree of humidity;
 - in 2013, the plant community in the meadow comprised grasses and shrubs (*Genisteae* (brooms) and blackthorn), similar to the situation before the work. The species observed in 2010 were no longer present.

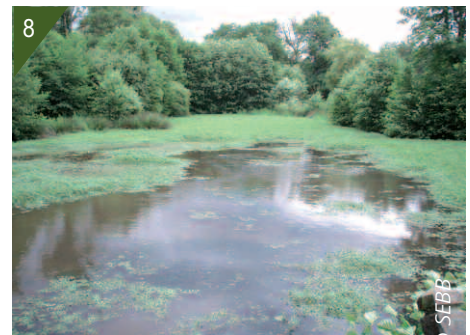
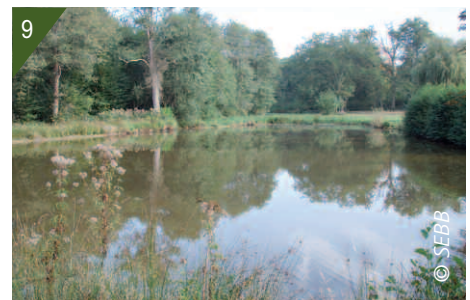
8. The pond just before the work (2008).

9. The pond in 2012.

- 2009. Sporadic, but regular regrowth of water primrose was observed in the pond and along the banks (probably due to plant litter buried during the work).
- 2010. Following the manual uprooting carried out in 2009, the sections of the pond under water were free of water primrose. However, the species was still present at the foot of the banks.

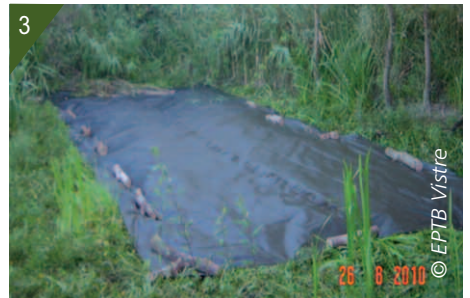
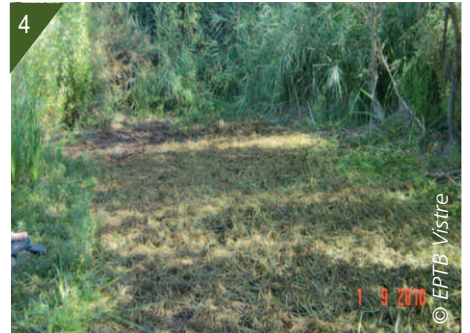
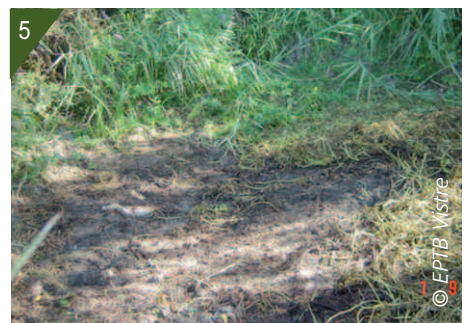
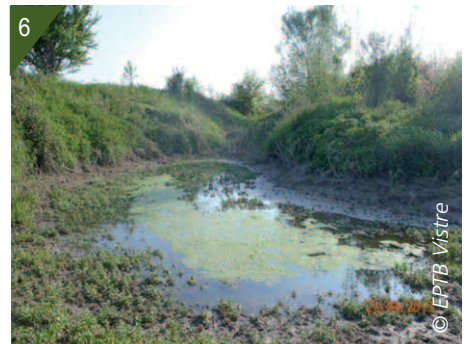
2. Uprooting water primrose with a school class in 2011.
3. Tarp covering an area colonised by water primrose.
4. Situation after 7 days of being covered by a tarp.
5. Situation after tarping and manual uprooting.
6. Site tarped in 2012 and naturally recolonised by native species in April 2013.

- In April 2013, natural recolonisation by native plants (Iris, Carex, *Veronica beccabunga*) was observed in the tarped areas.

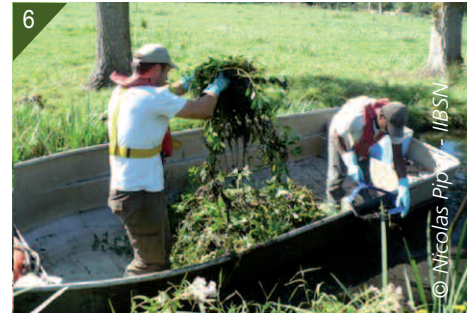
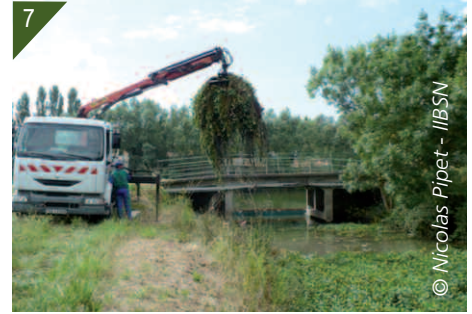
6. Manual uprooting.
7. Mechanical uprooting.

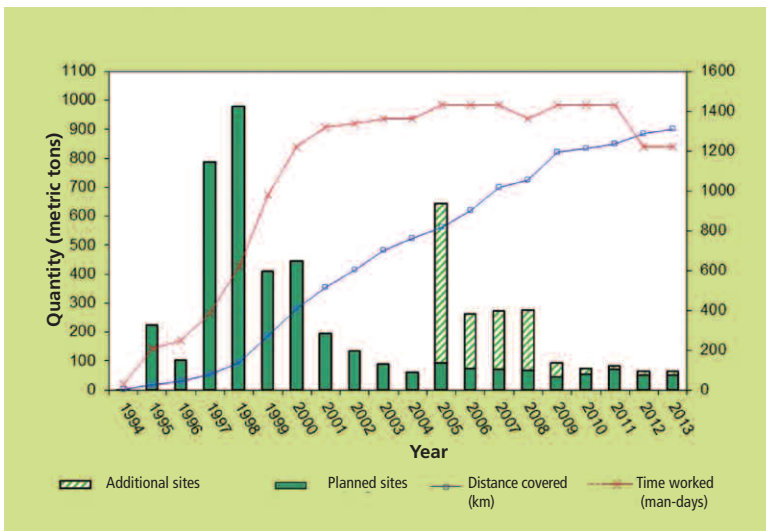
Water-primrose management work from 1994 to 2013. Distances covered, quantities harvested and time worked.

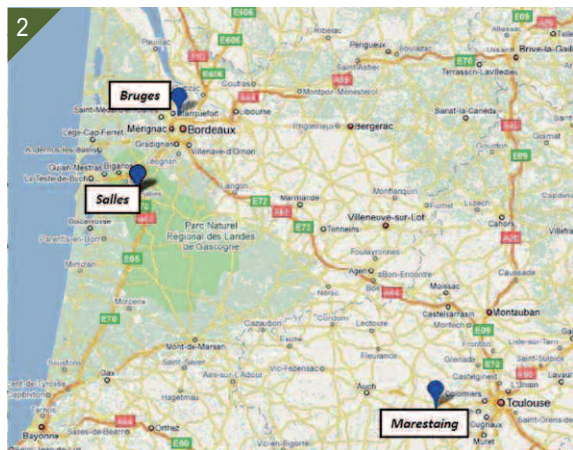
1. Map showing the inspected sites.
2. Study sites.

- 70 sites along 10 rivers in South-western France were inspected.
- The presence/absence of box elder and the degree of colonisation were observed on each site.
- Three study sites were selected in light of their high concentrations of box elder and the large areas covered:
 - the Bruges marshes natural reserve contained a coppice that had started to age with an increase in the number of fairly large-diameter trees, though smaller trees continued to represent a majority of the population;

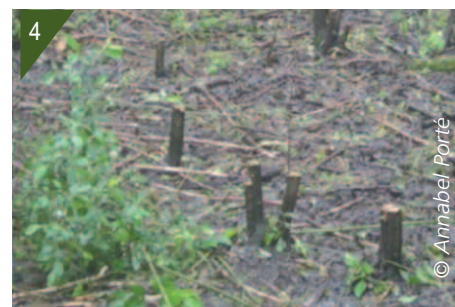
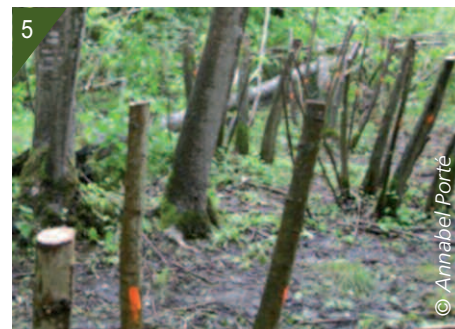
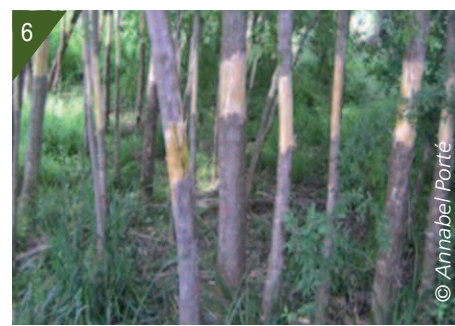
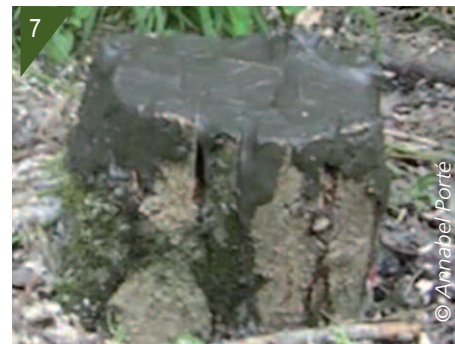
4. Treatment C.
5. Treatment H.
6. Treatment E.
7. Treatment J.

- high growth potential, some shoots reaching a high diameter to length ratio;
- the number of shoots per tree increased significantly in 2011;
- the shoots were more vigorous on the trees cut to a height of 1.3 metres;
- the juglone-based treatment (J) was not effective, which may be due to the low concentration (walnut leaves were used and not pure juglone);
- the five largest shoots were smaller in size when the bark was stripped from the trees (treatment E), a treatment that tired the trees.

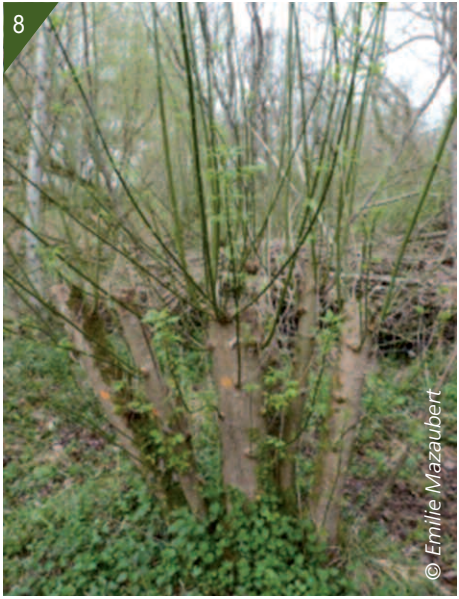
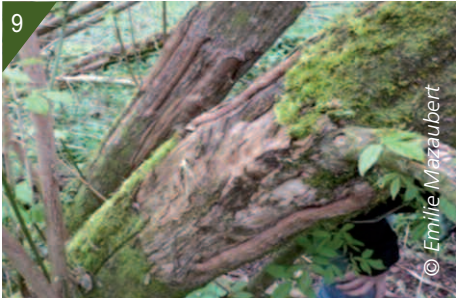
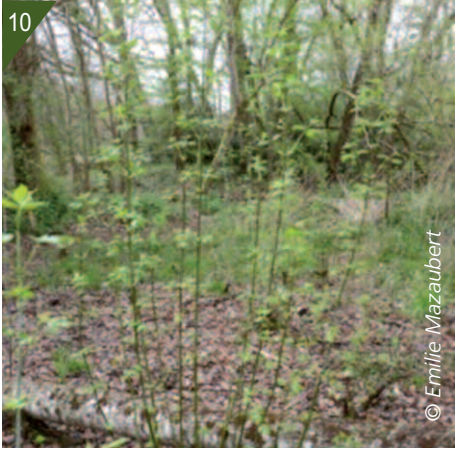
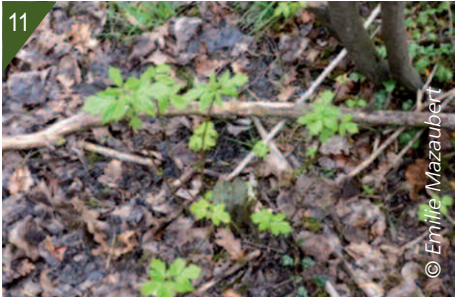
Results of the treatments.
 8. Treatment C.
 9. Treatment E.
 10. Treatment H.
 11. Treatment J.

- mortality increased after two years of treatment;
- average mortality rates varied significantly for a given treatment depending on the site due to the influence of abiotic (environmental conditions) and genetic (origin of the trees) parameters;
- stripping of the bark was the most effective in spite of the healing process (exsudat) observed on certain sites that slowed the decline of the trees.

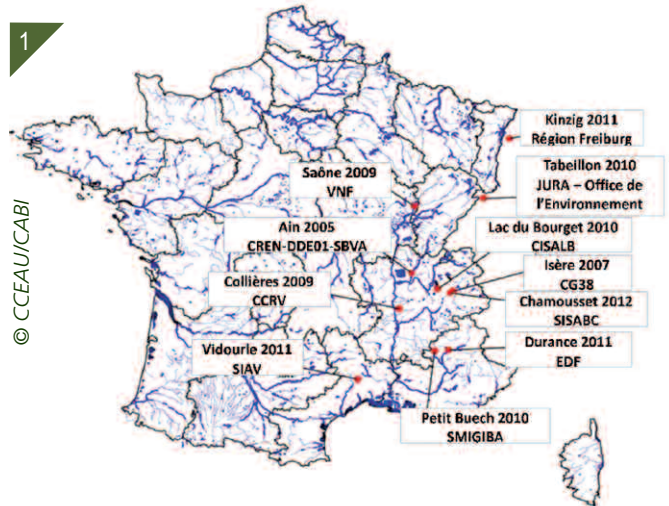
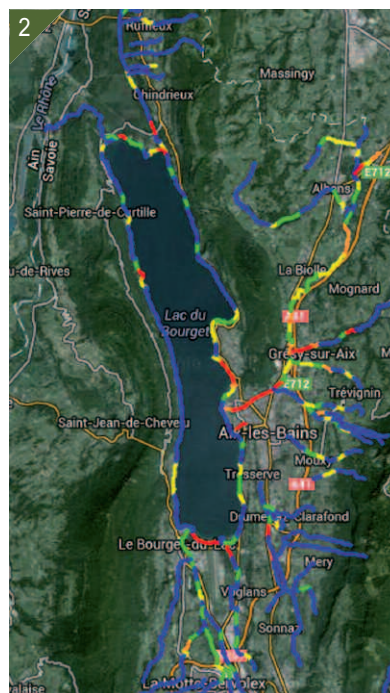
1. Study sites (2005 to 2012).

2. Map showing the invasion stages of Japanese knotweed around Lake Bourget in France.

- From 2005 to 2013, the research programme was set up on eleven experimental sites in Eastern France, Switzerland and Germany.
- The trials were made possible thanks to a partnership with local participants where the managers proposed the sites and provided the funding. CCEAU and/or CABI developed the experiments and monitored them.
- The sites were selected to ensure a wide range of conditions (soil types and climate) in order to check whether the plant reacted in the same manner on all sites to the mechanical technique.
- Technical feasibility was tested during actual field trials addressing problems such as access, water levels, flood risks, bank stability, infested waste and the impact of large machines.
- The solutions found for all the above difficulties resulted in the progressive development of a precise method protocol.

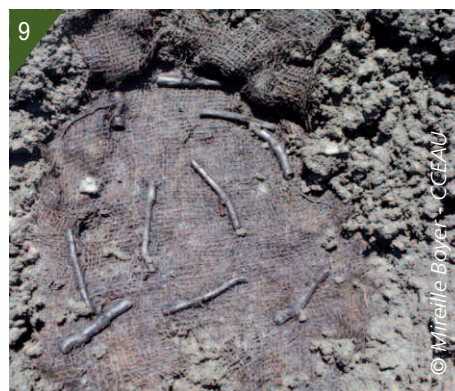
8. Diagram of a rhizome.

9. Collecting the control rhizomes.

- If the site owner is not in a hurry, it is best to leave the tarp for at least 18 months.
- Otherwise, it is necessary to set up a monitoring system for plant decomposition using control rhizomes to determine whether the tarp can be removed without any risk of regrowth:

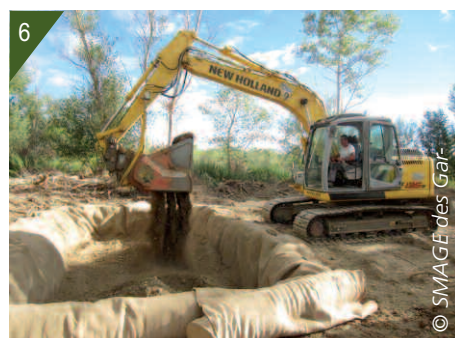
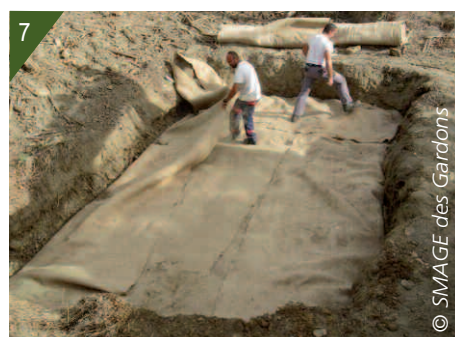
3. Manual uprooting of knotweed.
4. The uprooted material is sent two or three times through the grinder.
5. Grinder in the bucket.
6. The ground material is deposited in the hole from which the plants were uprooted.
7. It is then covered with a biodegradable fabric.

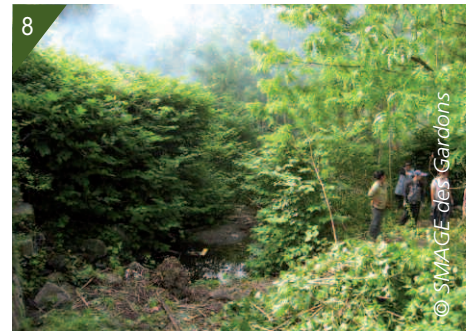
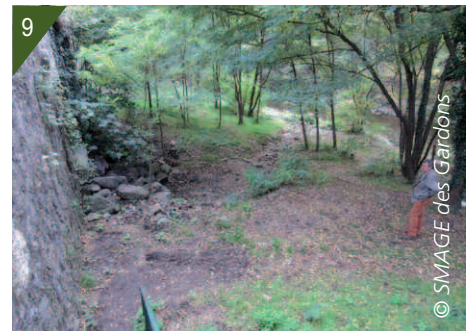
8. 9. The Grand'Combe sector colonised by Japanese knotweed in 2009 and after the work in 2013.

■ On the Grand'Combien site, five years after the intervention, the results are very positive. The knotweed has retreated along the entire river section and only rare shoots may now be found. The general public is present on the banks much more often and the quantity of waste thrown by local residents from the road has dropped regularly. The work using unemployed people had a positive social impact in that the project was fully supported by the employees of the Cévennes development association (TEDAC) and approved by the local residents.

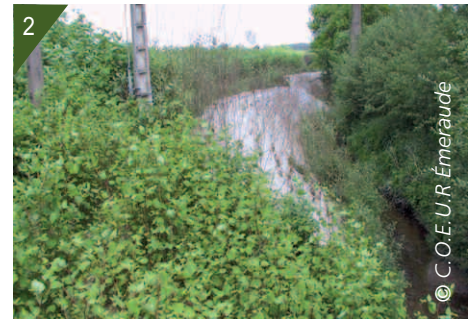
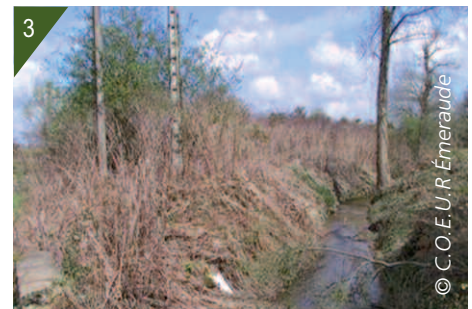
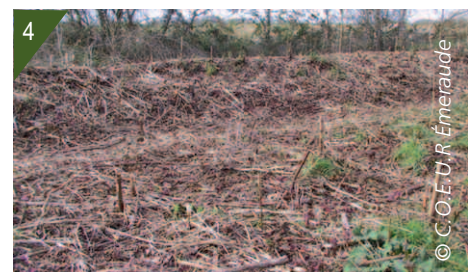
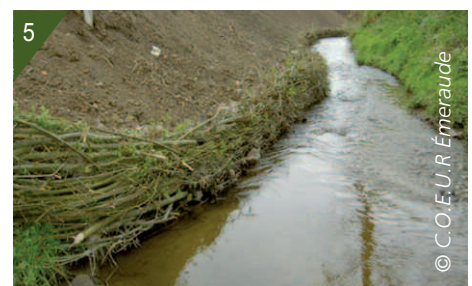
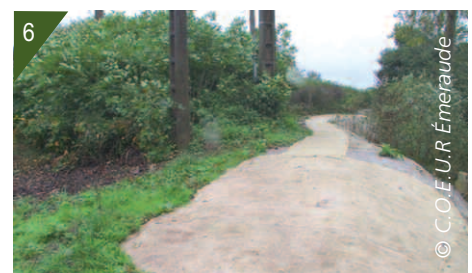
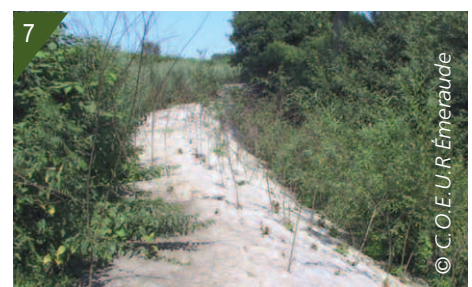
2. 3. The work site at different stages of colonisation and work.
4. The site following manual uprooting.
5. Installation of bundled willow wood (fascines) along the banks.
6. Tarped area.
7. Tarped area with planted willow cuttings.

- As early as 2007, the river bank was recolonised by approximately 20 native species commonly found on river banks.
- The method employed was effective in recreating competitive conditions for native species, but could not completely eradicate the knotweed.

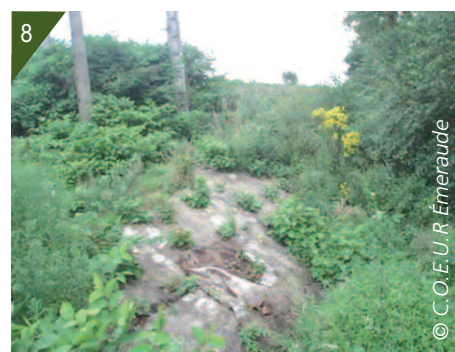
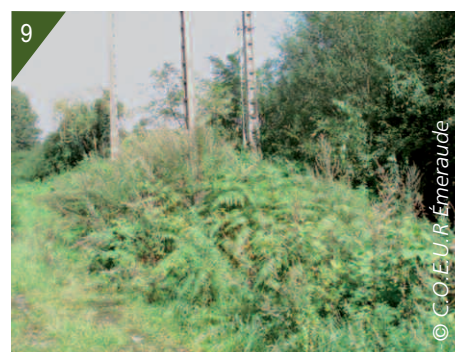
8. Tarped area during regrowth of native species.
9. Tarped area after regrowth of native species.

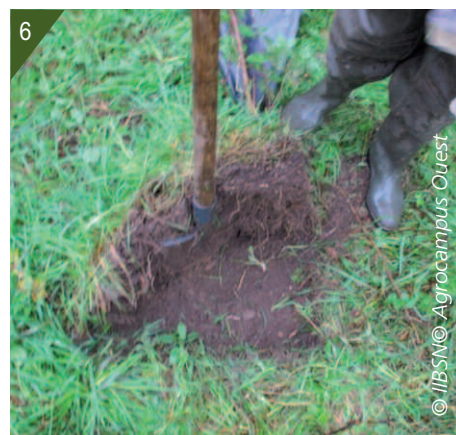
6. Collecting a biomass sample.

■ Biomass samples:

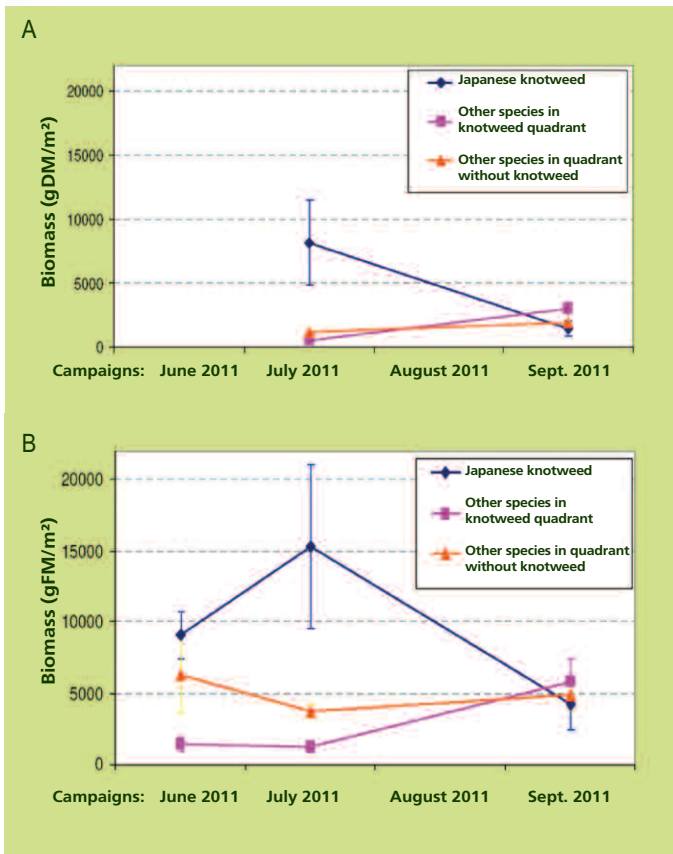
A. Average dry biomass.
B. Average fresh biomass.

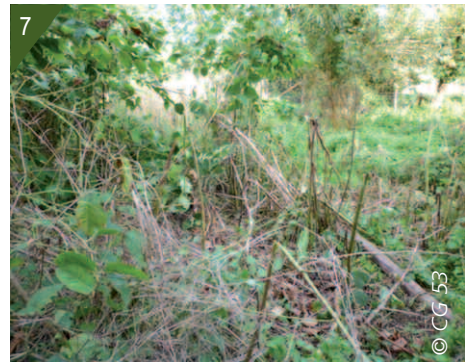
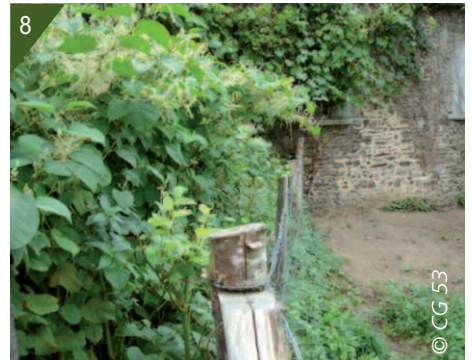
7. Grazed area at the end of September 2011.
8. Comparison between a control zone (left) and a grazed area (right) in 2012.

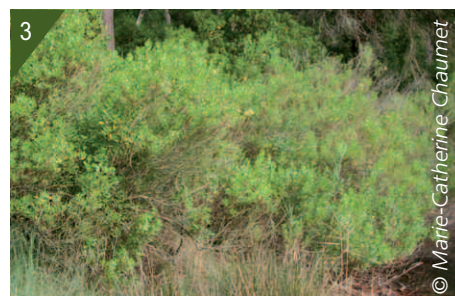
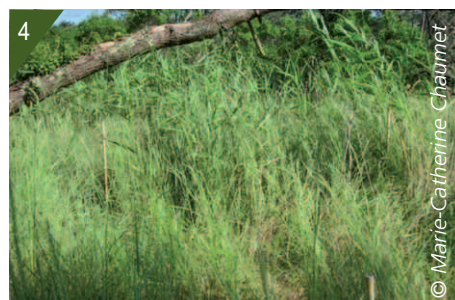
3. Island no. 4 in July 2007.

4. Island no. 4 in July 2013.

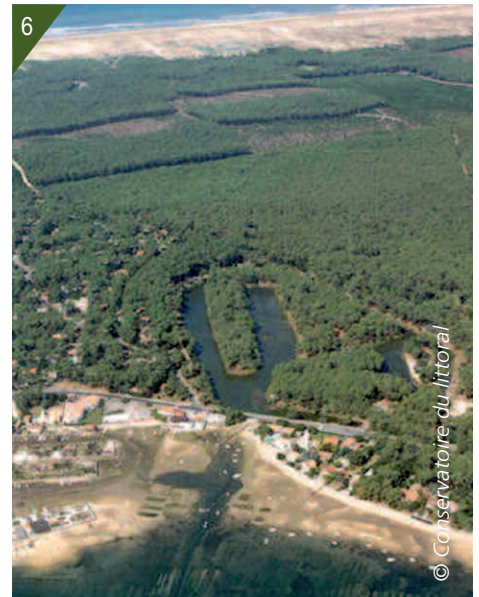
6. Aerial view of the Pirailan reservoirs.

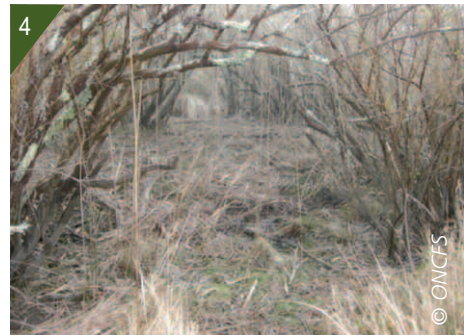
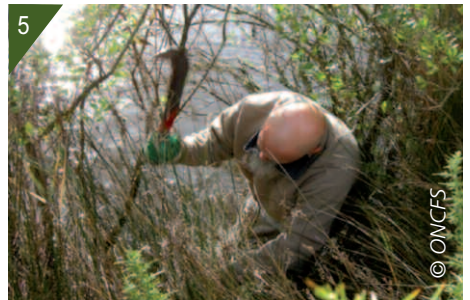
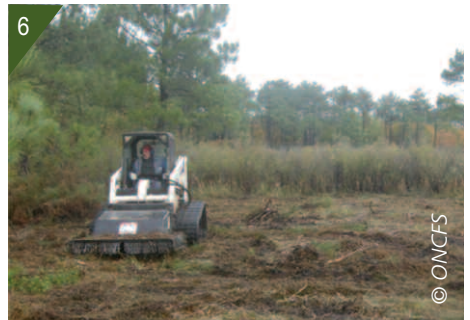
4. An area colonised by groundsel bushes.
5. Manual cutting.
6. Rotary cutter in action.

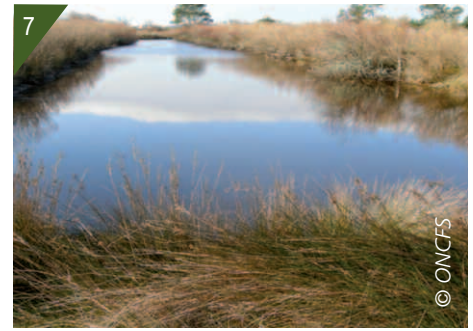
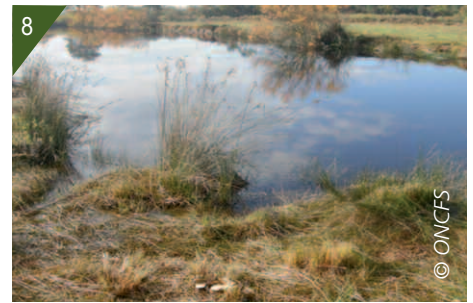
7. Fish reservoir prior to manual cutting (November 2009).

8. Fish reservoir after manual cutting (November 2009).

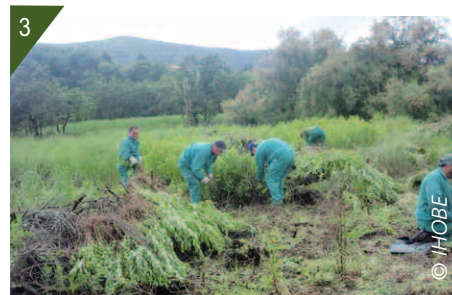
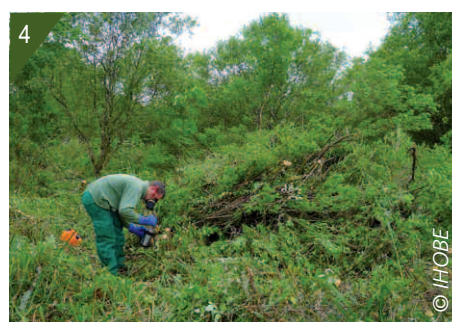
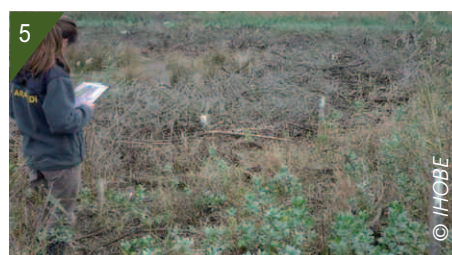
2. Urdaibai biosphere reserve.
3. Manual uprooting.
4. Use of a herbicide.
5. Monitoring regrowth of groundsel plants.

- Technique used on adult plants and new shoots.
- Active ingredient: glyphosate.
- The herbicide was applied on the trunks using brushes, following cutting.
- This technique is possible only under favourable weather conditions (no wind or rain).
- Requires safety measures (gloves, masks).
- Highly effective and less expensive than manual uprooting.

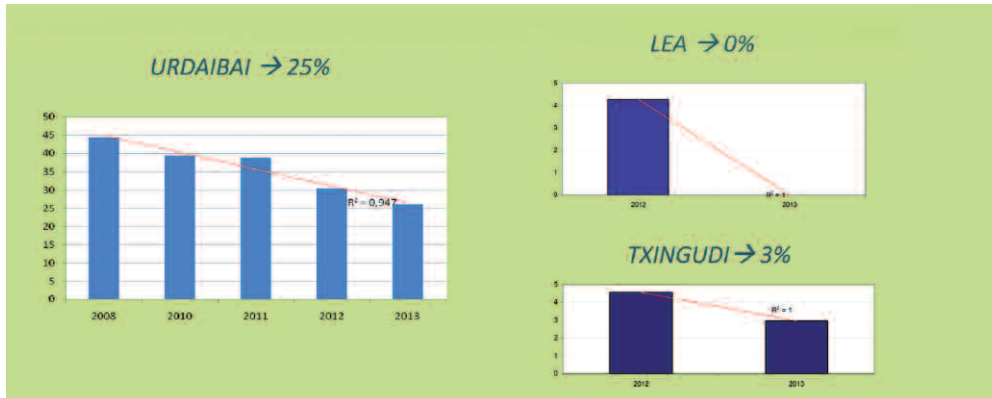
Change in the observed number of groundsel plants starting to grow again.

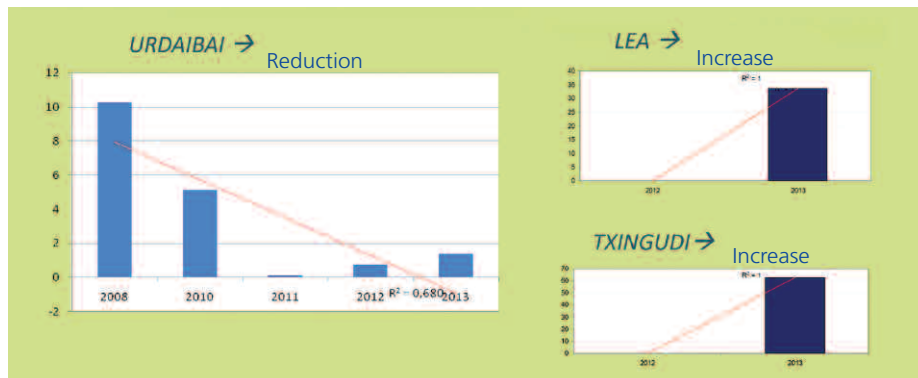
Change in the observed number of groundsel seedlings.

■ A reduction was observed in the Urdubai reserve, but an increase in the estuaries of the Lea and Txingudi Rivers.

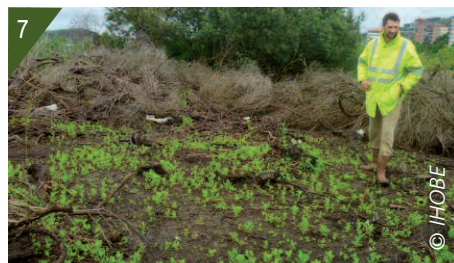
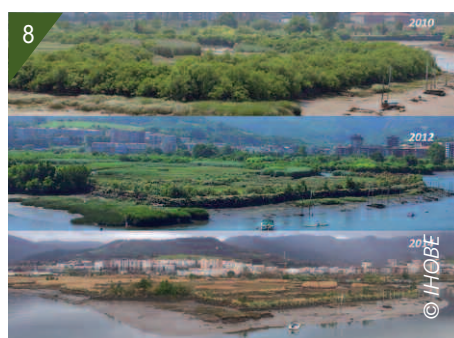
6. 7. New seedlings in a previously treated area.
8. Results of management work in the estuary of the Bidasoa River.

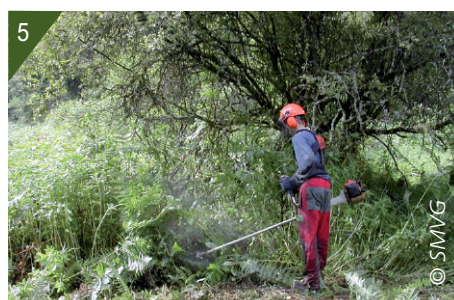
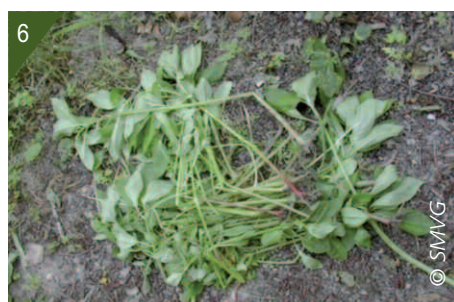
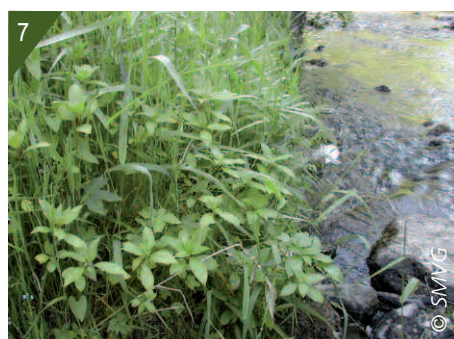
4. *Impatiens glandulifera*.
5. Clearing with a brushcutter.
6. Uprooted and cut plants deposited on the bank.
7. Bank colonised by *Impatiens glandulifera*.

■ The stalks were broken into several pieces.

■ The plants were subsequently transported to the incinerator in Limoges in October.
