Invasive alien species in aquatic environments
Practical information and management insights

Volume 2

Management insights

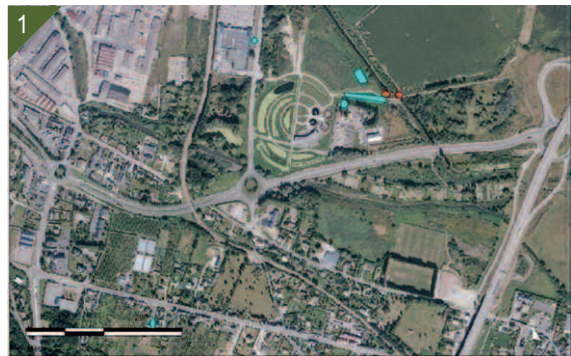
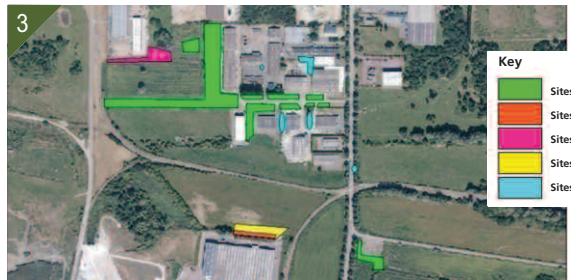
Key	
Green	Sites known in 2007
Orange	Sites discovered in 2008
Pink	Sites discovered in 2009
Yellow	Sites discovered in 2010
Light Blue	Sites discovered in 2011

1. 2. 3. 4. Intervention sites from 2007 to 2011 in four sectors of CCPH.
 BD Ortho - IGN Paris 2006. Data: Être & Boulot / CFEN.
 Production: Florence Thinzilal, September 2011

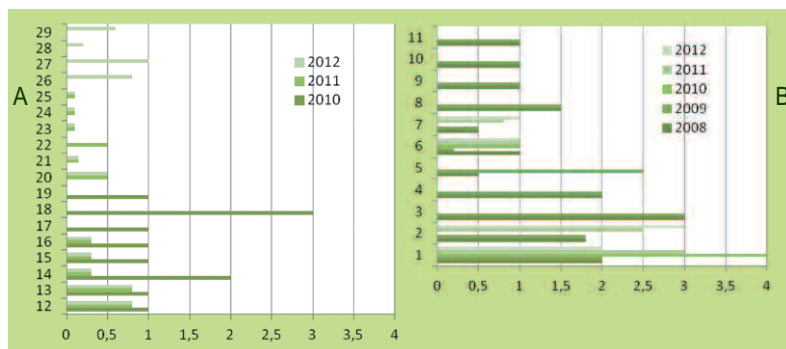
A. Density of plants per square metre per year on sites discovered in 2010.
B. Density of plants per square metre per year on sites discovered in 2008

■ Giant hogweed disappeared from two sites (no. 19 and 11) following the work in 2010.

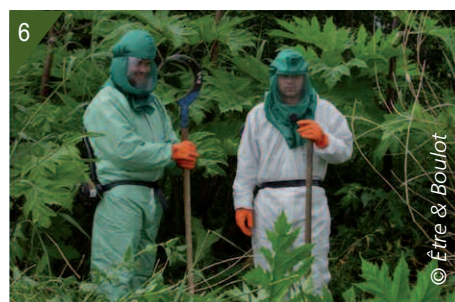
5. Giant hogweed (*Heracleum mantegazzianum*).
6. Fully equipped personnel.
7. Plant matter left on site.
8. Mechanical cutting using a rotary cutter.

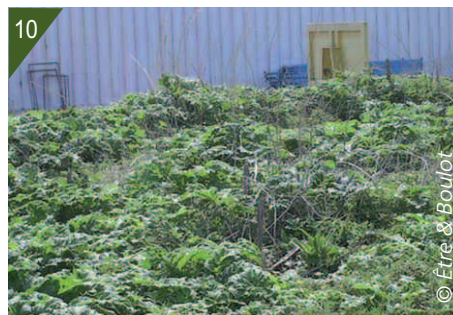
9. Site colonised by giant hogweed (*Heracleum mantegazzianum*) in 2009.

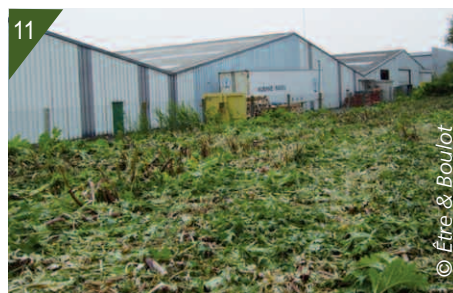
10. The same site in 2011 prior to the annual work.

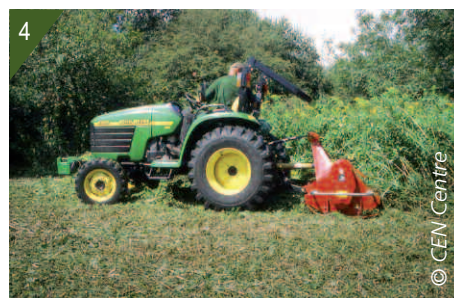
4. Mechanical shredding using a rotary cutter.
5. Mechanical means used to uproot the plants and strip the top layer of soil.

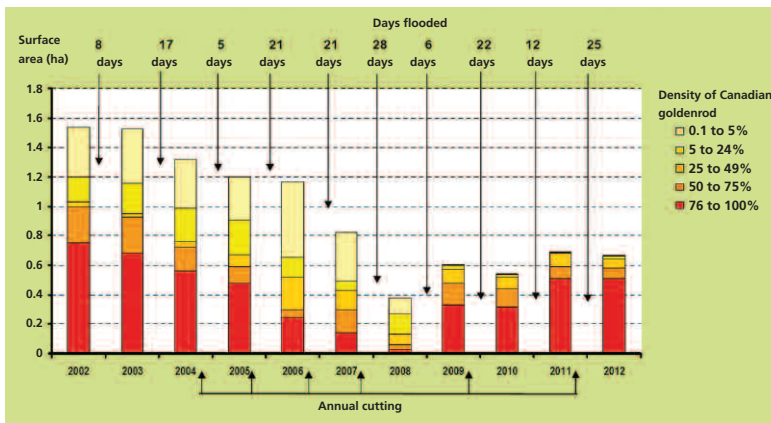
Surface areas colonised by Canadian goldenrod in the Chênevières meadows from 2002 to 2012. Source: Centre nature conservatory.

- From 2002 to 2012, the colonised surface area was reduced by 55%.
- A number of highly colonised areas (density greater than 76%) persist, in spite of the overall reduction observed from 2002 to 2008. The proportion of these areas rose sharply from 2008 to 2012.
- Colonised surface areas increased markedly the year following a year without any work:
 - an increase of 60% from 2008 to 2009;
 - an increase of 28% from 2010 to 2011.

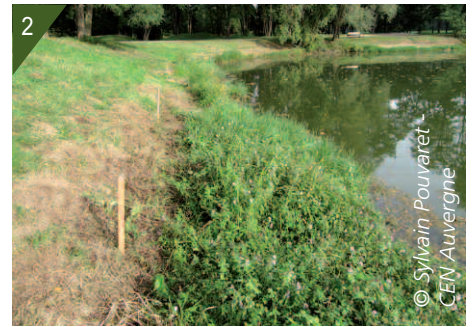
2. A plot prior to the work in September 2011.
3. A plot after the work in August 2012.

■ The water finger grass recolonised all the plots in 2012, but occupied less surface area. This result demonstrated the difficulty of total elimination, even by combining uprooting, turning of the soil and burning of the roots and rhizomes.

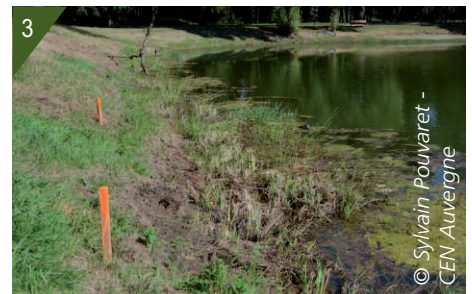
Work done on plot 3:

- manual uprooting of plants in the water and use of the brushcutter;
- thermal weed control of all vegetation, over an area 1 to 2 metres wide;
- manual turning of the soil;
- thermal weed control to burn the rhizomes.

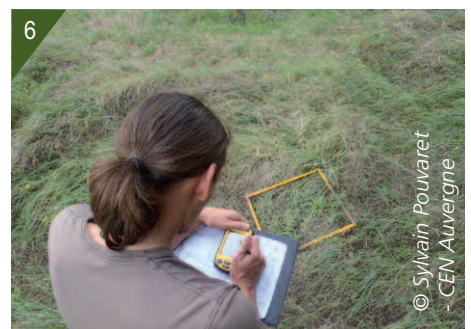
4. Reed canary grass.
5. Creeping bentgrass.
6. Phytosociological monitoring.
7. Manual uprooting.

■ In addition to the phytosociological studies on the plots, an inventory of the points where water finger grass was present was conducted around the entire lake in order to assess the spread of the species on the site.
